WHAT SHOULD AN AFFORDABLE HOMESTEAD LOOK LIKE FOR THE FLOOD AFFECTED AREA?

Authors: Shahriar kabir, Adham Siddiqui, Sakib Abdullah Khan

Department of Architecture

Ahsanullah University of Science and Technology (Bangladesh)

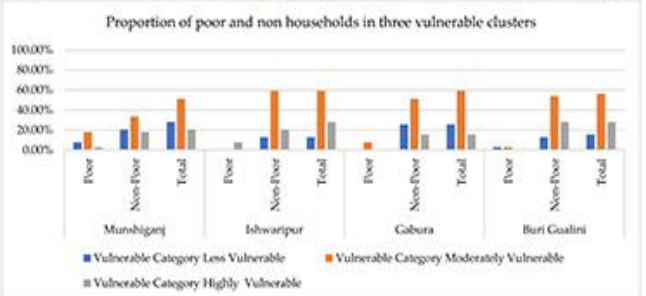
HOUSEHOLD VULNERABLE CLUSTERS BY POVERTY CATEGORIES.

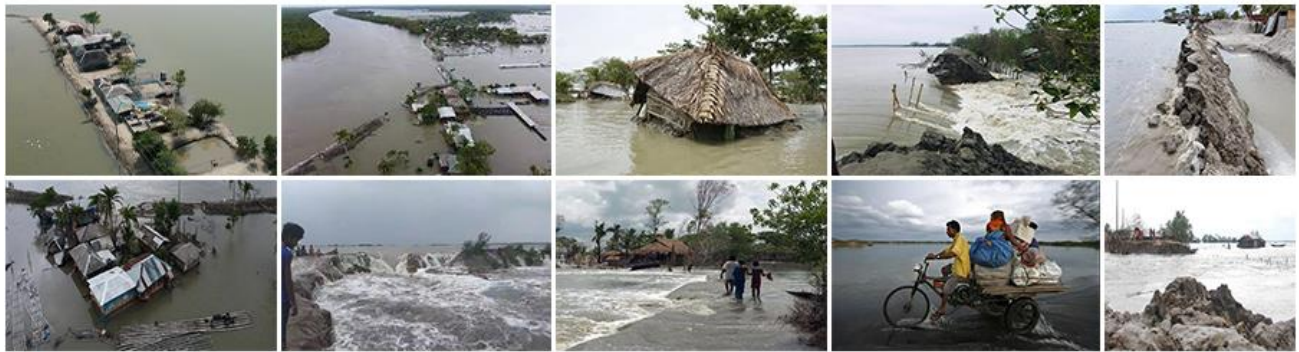
SITE PICTURES AFTER NATURAL DISASTER

The recent Super Cyclone, 'Amphan' causes a heavy damage. Gabura has been flooded due to the collapse of the coastal embankment. Kholpetua River near the coastal embankment inundated two villages in Nebubunia area under Gabura Union. New areas have been submerged in tidal water at night as water continues to enter through six points of the eroded part of the embankment. It destroyed homes, polders, embankments, roads, electricity poles, mobile phone towers, bridges and culverts, with the exact costs still being tallied. Many agricultural fields and fish farms were overwhelmed by the saltwater storm surge.

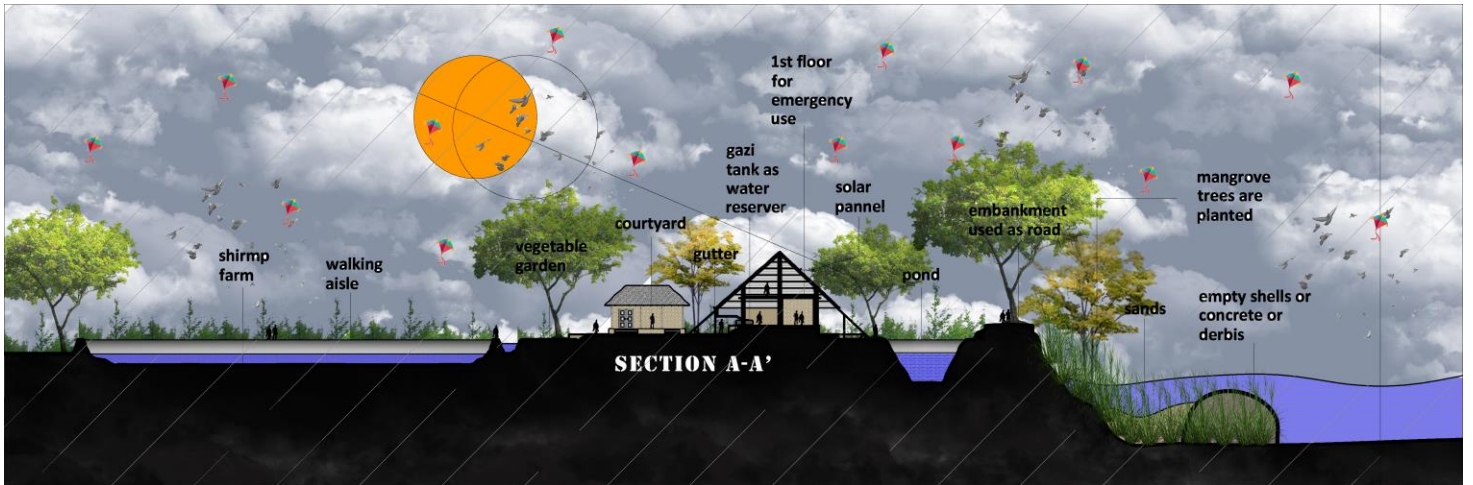
Figure: section aa'

Stilt roots of mangrove trees are comparatively stronger against cyclones and tidal surge in the Sundarbans, however bio-mimicry of stilt root is done to achieve resilience, and maintain the harmony with the nature. A practice of mitigation might bring stability to the people of lower Sundarban villages, which will decrease high dependency on cyclone shelters, which barely attracts the local people, their beliefs and culture. While choosing the material, following the stilt root structure system, local load bearing wood is avoided, as it might harm the Sundarbans ("Sundari" wood, used for load bearing, is banned to cut without permission by the authority. Other such trees are also important to preserve for the forest to protect itself). For very good flexural strength, and the very good availability, bamboo is used as the material of the structure. It can be easily transported through boats to the selected site, Gabura at Satkhira, Bangladesh. Well processed bamboo (with saline water, borax, etc.) lasts for decades.

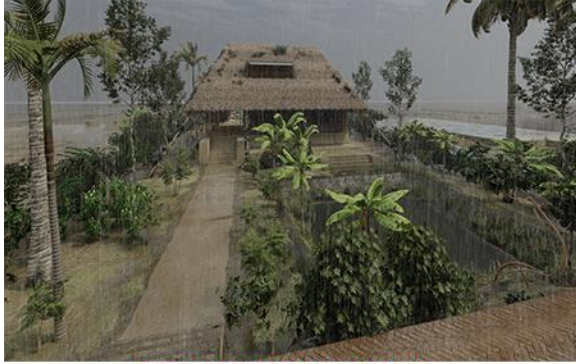
MAIN ENTRY DURING MONSOON SEASON

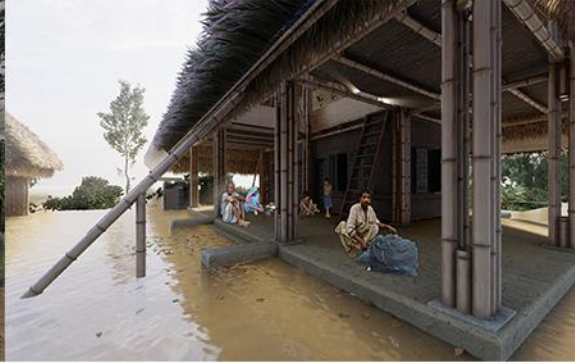
INTERNAL CONDITION DURING MONSOON SEASON
